THE UNITED STATES
STRATEGIC BOMBING SURVEY

THE EFFECTS
OF
THE ATOMIC BOMB
ON
HIROSHIMA, JAPAN

Volume III

Physical Damage Division

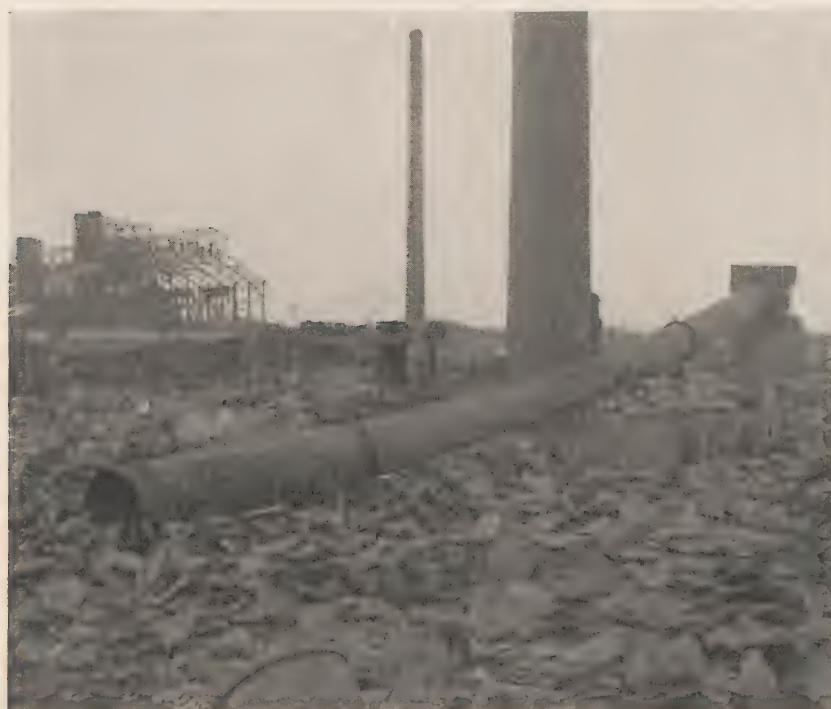
PHOTO 22-XIV. Stack 28. Steel with brick base, 6,900 feet from GZ.
Failed at anchorage to base.

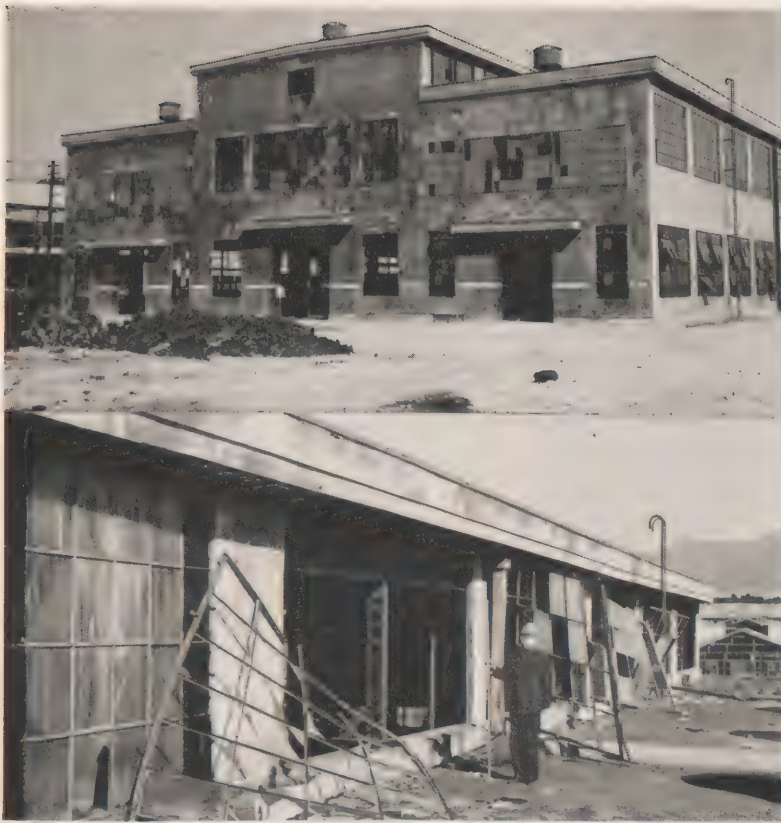
PHOTOS 1-XV and 2-XV.
Building 20 (Fig. 1-XV). No
damage other than glass break-
age and distorted window
frames occurred to this modern
concrete roofed industrial
building.

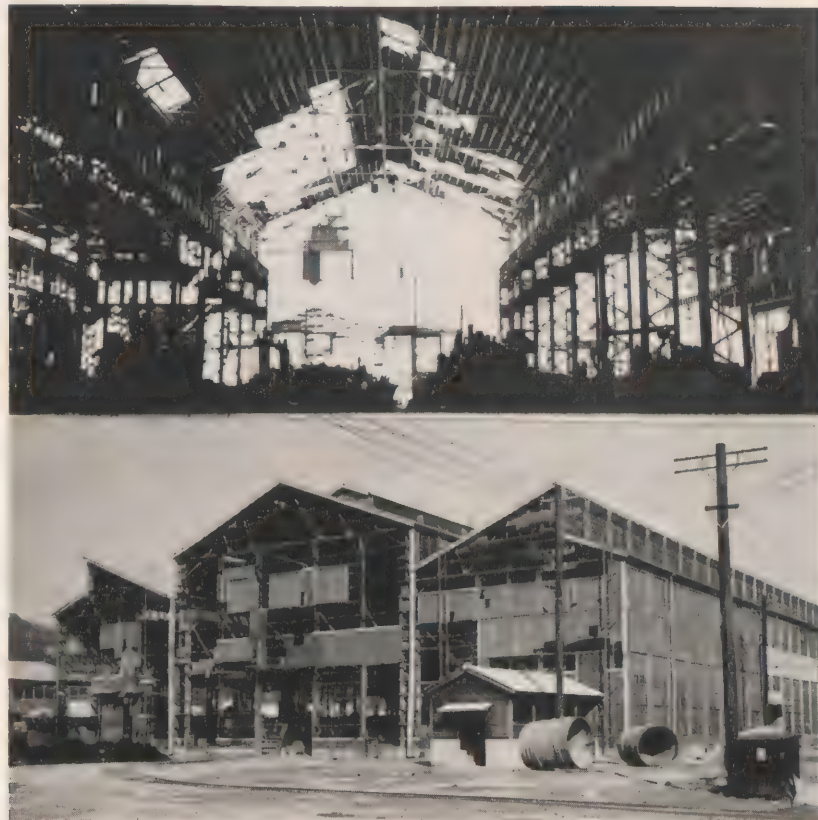
PHOTOS 3-XV and 4-XV.
Building 30 (Fig. 1-XV).
Interior and exterior views
of this light steel framed in-
dustrial structure, show the
character and extent of roof
and sidewall stripping.

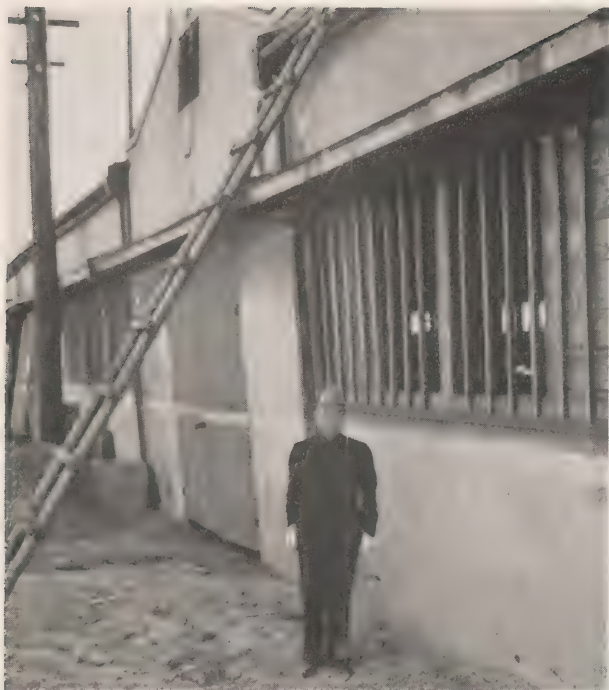
PHOTO 5-XV. Building 24 (Fig. 1-XV). This light, wood-framed, one-story structure, covered with stucco, was blown about 12 inches out of plumb by the bomb blast, but its usefulness was unimpaired.

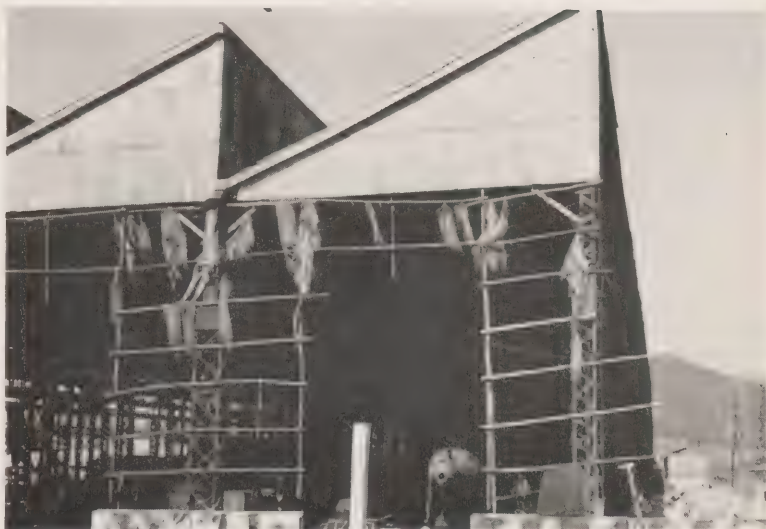
PHOTO 6-XV. Building 71 (Fig. 1-XV). The submersible transport assembly building, in the southeastern part of the plant, sustained some wall stripping.

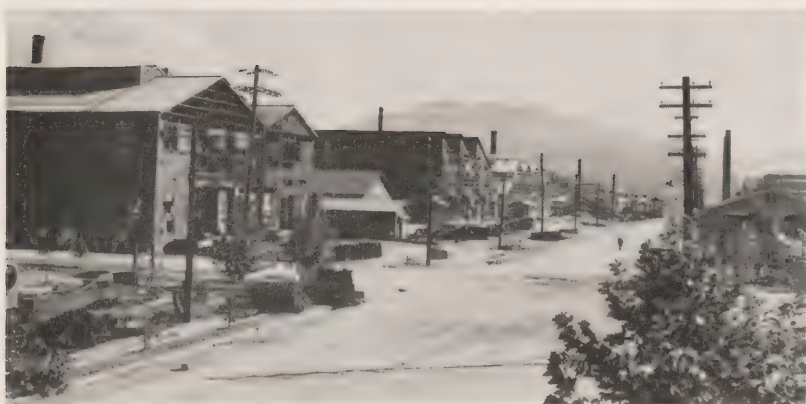
PHOTO 7-XV. This general view shows the uniformity of superficial damage to the buildings in the plant area.
